ArresterWorks

Example Arrester Forensic Analysis

Background

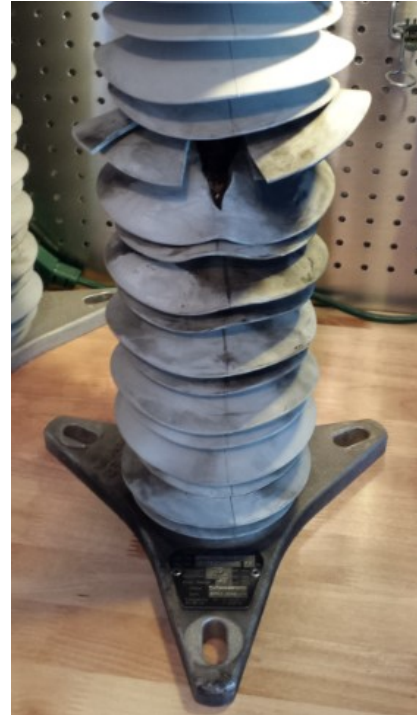
The failed unit (Fig 1) had experienced significant fault current during the final failure event which ruptured the rubber at that point.. The unit did not shatter which is by design. All disks were still in the unit. Both the top and bottom seal were in good condition and did not appear to be broken.

Figure 1 – failed arrester 21353008506

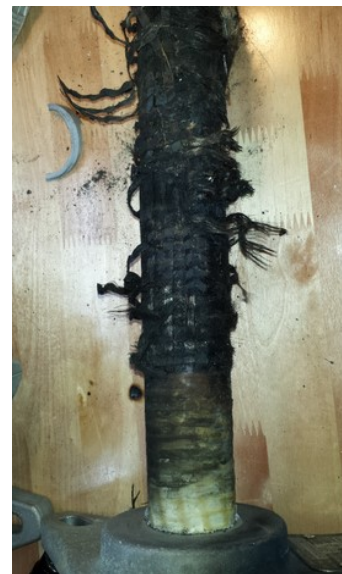
Figure 2 - Failed arrester 21353008506 with housing removed

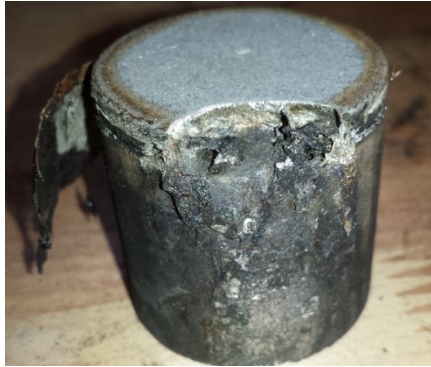
Review of internal components showed that all disks had carbon on the sides. One disk showed significant external damage (Fig 3) and three had evidence of external tracking (Fig 5). It was evident that the arrester had experienced a long term low current overvoltage resulting in the depolymerization of the fiberglass wrap (Fig 4).

Figure 3 - Carbon and melted aluminum as a result of flashover.

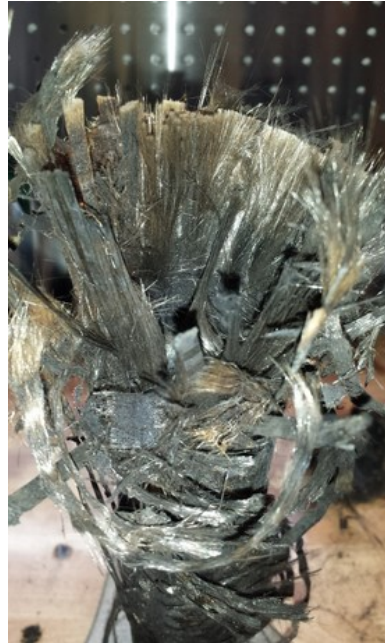
Figure 4 - Depolymerization of fiberglass wrap

Based on the condition of the fiberglass wrap (depolymerized) and the events as described by Perry, arrester 2153008506 failed due to a long term low current overvoltage that occurred while the system was single phasing, and it would have not been visible outwardly. When the failed arrester was energized a second time the arrester internally flashed over, faulted to ground and ruptured. Single Phasing on Wye-Delta circuits is explained in more detail in Annex B.

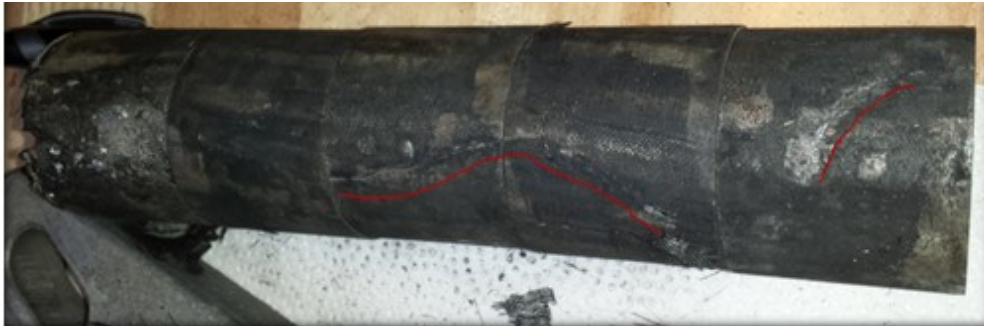
Figure 5 - Carbon on disks from failed arrester 21353008506. Red line traces tracking on side of disks.

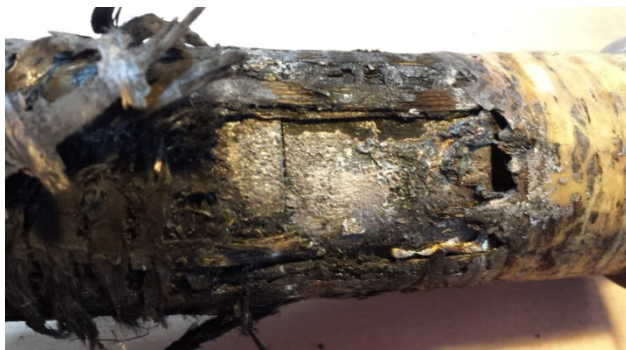
Figure 7 – Main expulsion point of failed arrester module

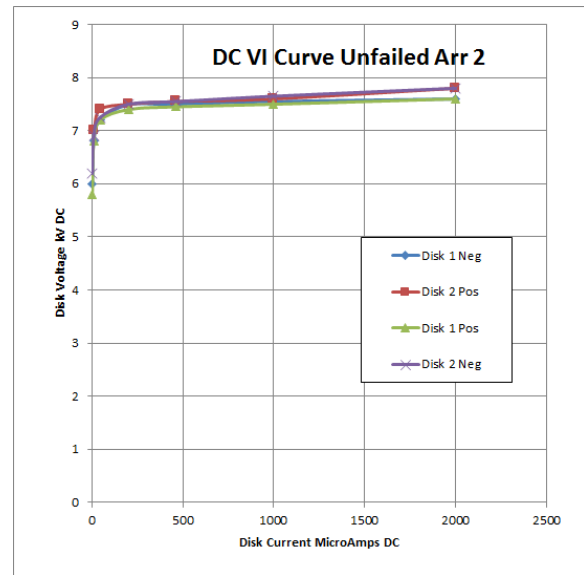
Because the disks positive and negative characteristic curves are very similar we know that there was no extra high lightning surge to these arresters. (Figure 9)

Figure 9 - VI Curve of disk from failed arrester

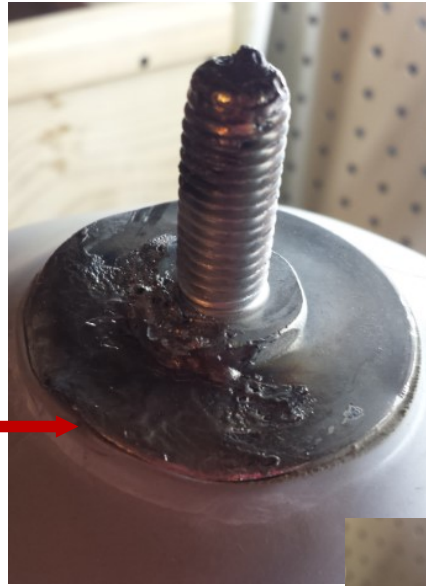
The two (2) partner arresters showed some signs of burning and arc marks on the top studs and name plates (Fig 12), which is believed to be collateral flashover from the failed arrester. There was considerable arc damage to the top of arrester 21353008505 resulting in the seal to be compromised (Figure 10), the bottom seal was intact. Both the top and bottom seals of arrester 21353008504 were intact. Removal of the housing from the partner unit 2153008505 showed that the internal module was in like new condition (Fig 13) with silicone grease filling all the interstices of the filament wrap. The housing was not removed from arrester 21353008504 although it showed minor burn marks on the housing (Fig 12) there was minimal arc damage (Fig 11) and both the top and bottom seals are intact.

Figure 10 – Arc marks resulting from flashover on arrester 21353008505. Arrow points to area of compromised seal.

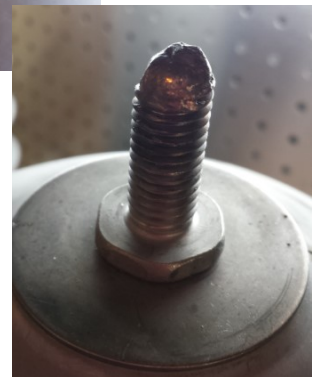
Figure 11 – Arc marks on top stud of arrester 2135008504.

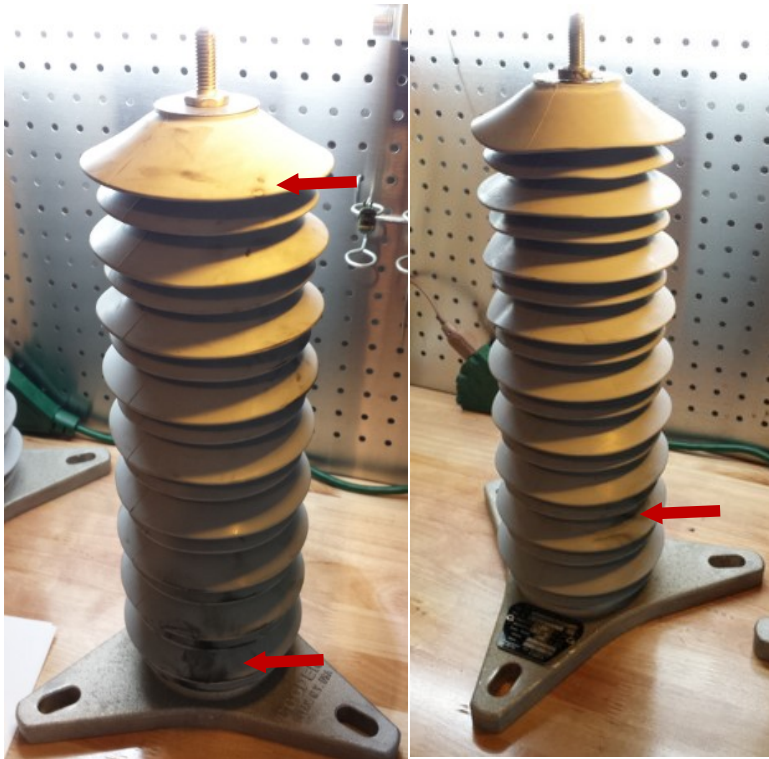
Figure 1 – Burn marks resulting from flashover on arresters 21353008504 (left) and 2153008505 (right).

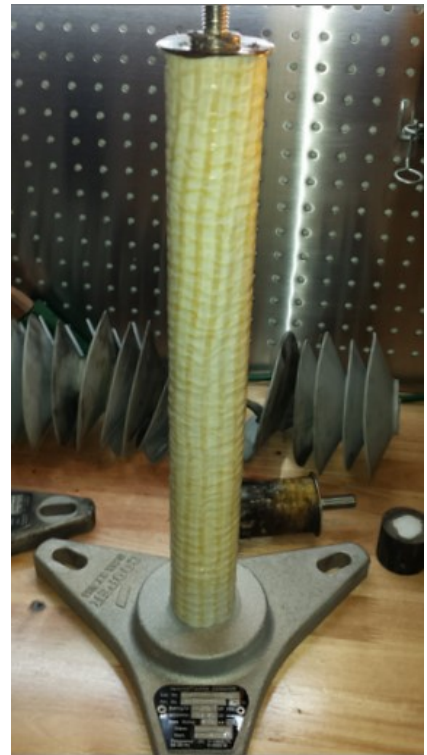
Figure 13 – Internal module of arrester 2153008505.
