Small Power Station Surge Protection Analysis and Plan

Jonathan Woodworth ArresterWorks

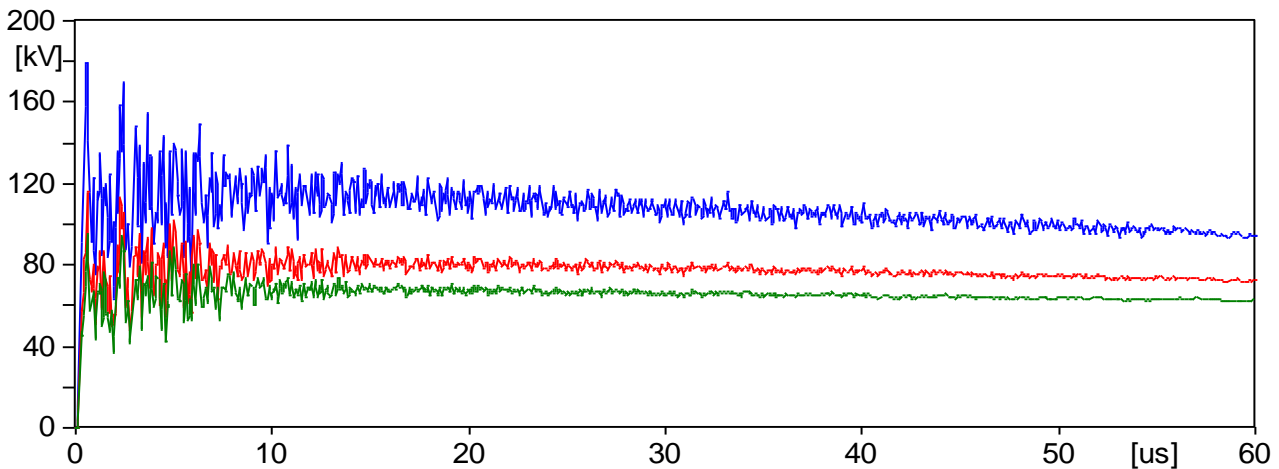
Figure 4 Strike to Riser Pole configured as it was on May 29, 2012 (Scenario 4,5,6)

Figure 4 shows that with a strike of 100kA magnitude to the span next to the riser pole, that the voltage level on the equipment in the EEM could see levels above the 170kV BIL rating. On the May 29th strike, there was no report of a strike that close, but this graph shows that excessive level was possible even with the 36kV arrester (A1) installed in the cabinet. It is possible that PT2 was pre damaged from the August 2011 event and that it did not take a full 170kV to cause it to fail this time. It could also be that the rapid rate of rise of the final surge (whatever level it was) could have done the damage.

- 5.2 The addition of a 36kV arrester (A1) at the utility side of breaker 52 was a positive move, but from Scenario 4 it appears possible that the system BIL could still be compromised if a high current stroke hit near the riser pole. (It is understood that this was not the case on May 29th, but perhaps it happened earlier when no operator was in house)

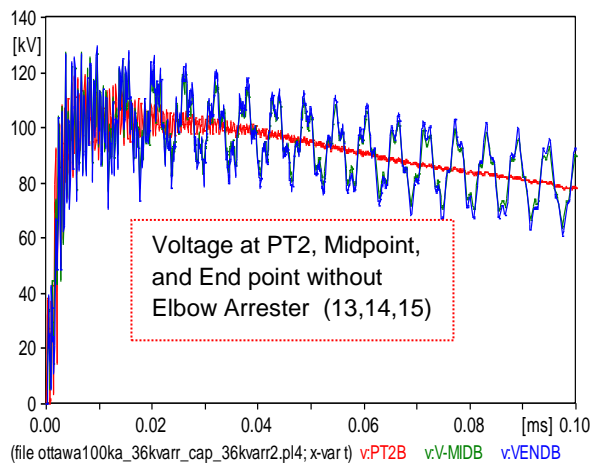
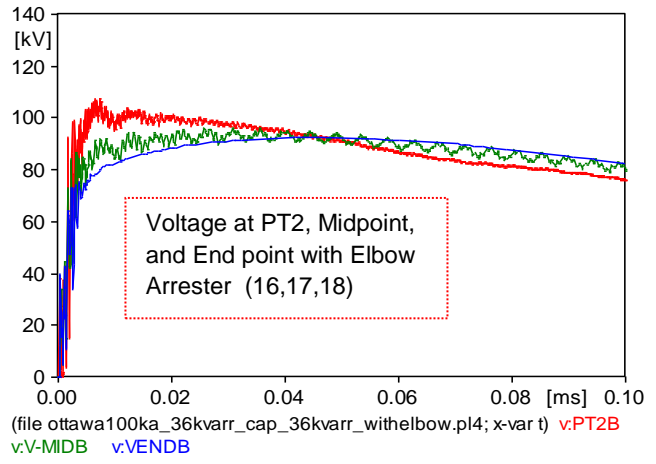
Figure 7a and b: Voltage at PT2, Mid point and end Point. 7a is without Elbow Arrester, and 7b is with elbow arrester. (Scenario 13,14, 15,16,17,18)

A check of the voltage at other points in the circuit, with the optimum configuration of Cap, 36kV arr, 36kV arr, show that the voltage at the midpoint in the circuit is higher than at PT2. With an elbow arrester installed at the end point these elevated voltages are removed. See Figures 7a and 7b.

- 5.5 To reduce voltage stresses at the midpoint and endpoint of the circuit, the addition of an elbow arrester at generator 3 is positive. Scenarios 13-18 show the improvement.
