Damaged 1950's Westinghouse Expulsion Arrester

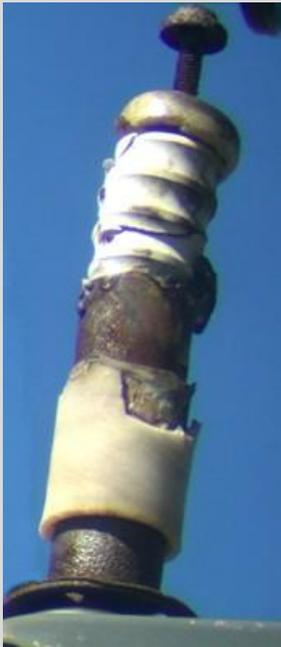
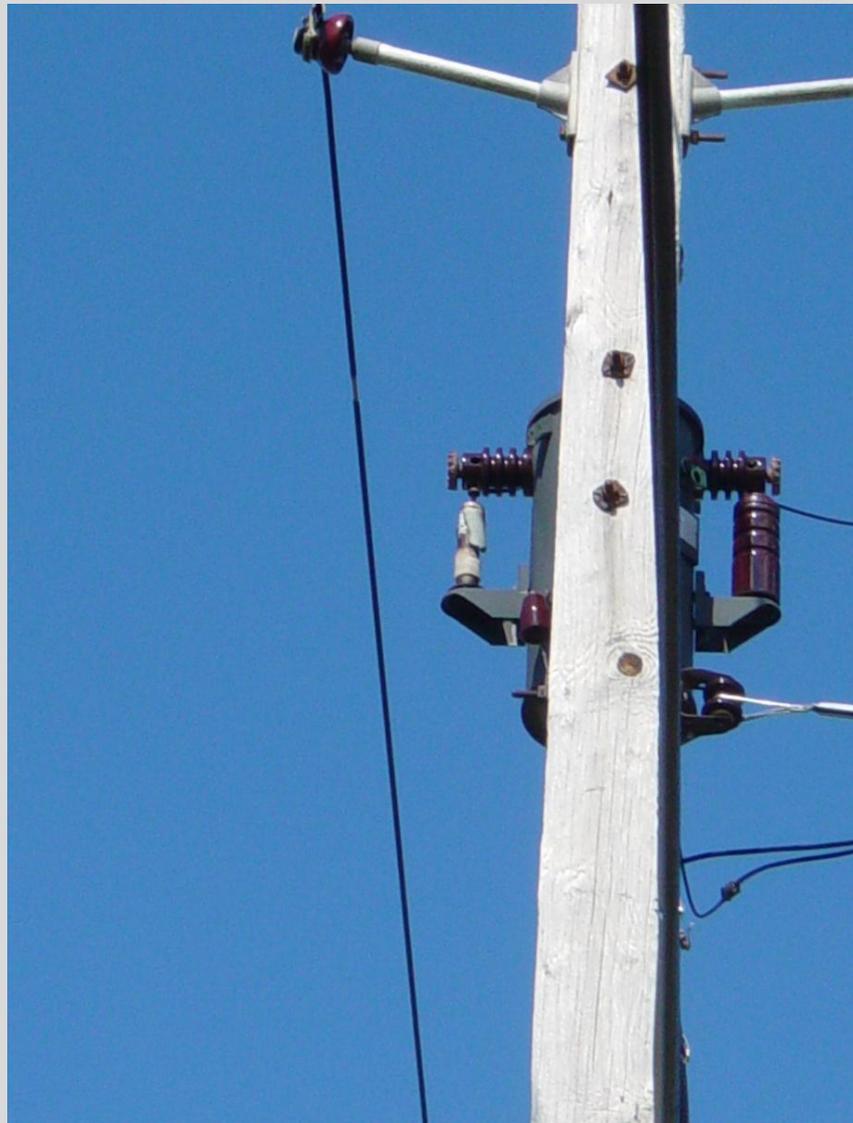
Externally gapped 1950 Westinghouse expulsion type arrester still on its transformer in spite of the fact that it has lost its porcelain housing. Looks like that side of the transformer is de-energized Photo taken in 2007
