ArresterWorks

Example Arrester Forensic Analysis

Background

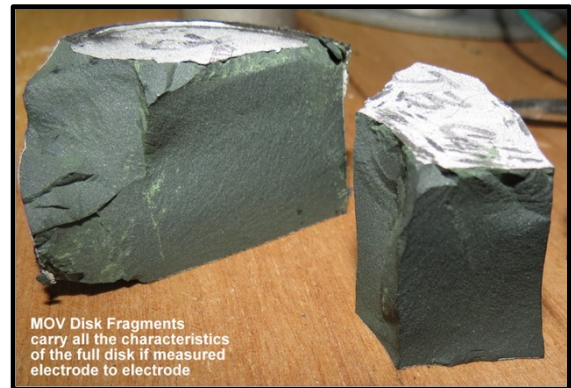
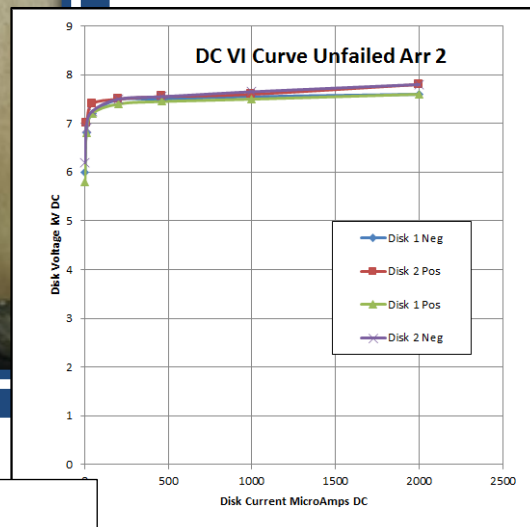
MOV Disk Fragments carry all the characteristics of the full disk if measured electrode to electrode

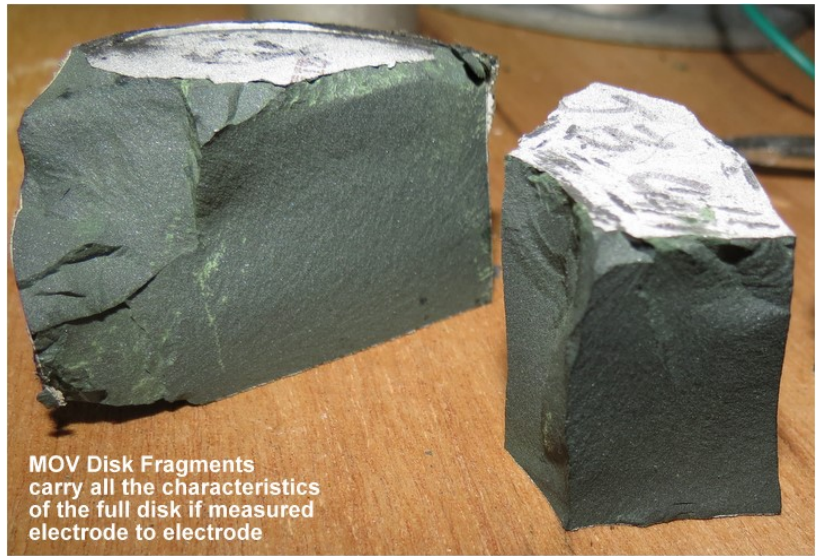
Disk Fragmenting

Disk Fragments are parts of a MOV disk that has been broken out of the center of the disk. By fragmenting a disk, any failed sections of the disk can be removed leaving side surfaces that are not conductive. The fragments show a VI characteristic very similar to the complete disk. Since the fragment has a smaller cross section, the absolute VI values may not be the same, but it is close enough to be considered the same. Watts loss will of course be different.

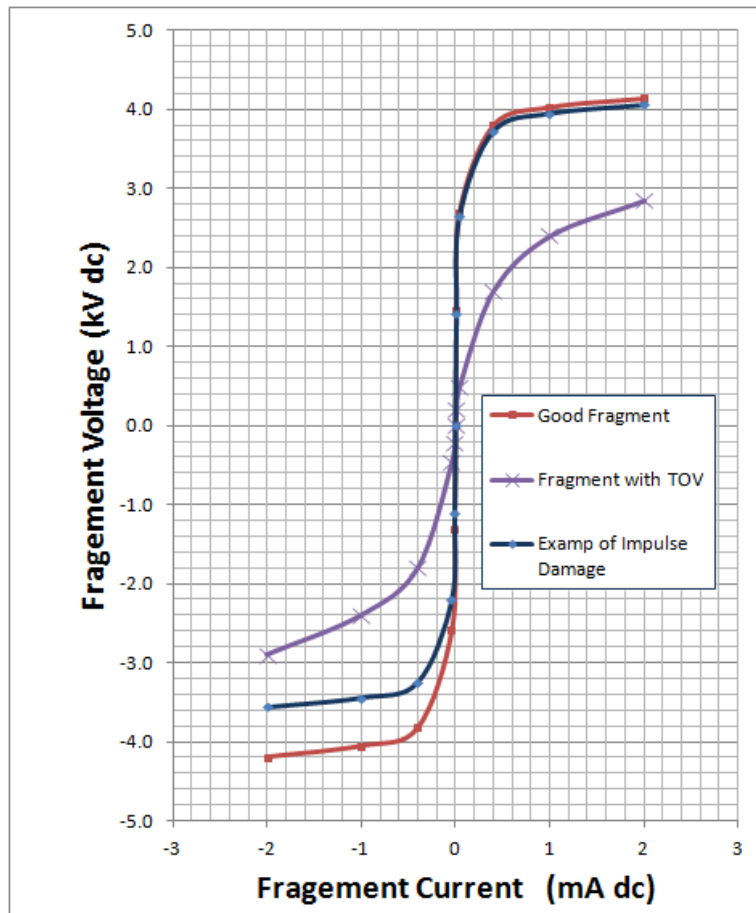
VI Characteristic Curves

1. The Good Curve has symmetrical Pos and Neg Characteristics. Also the knee of the curve is very pronounced.
2. The Impulse Damaged Curve shows Asymmetry in its VI Curve. The positive knee is higher than the negative knee. The knee is still pronounced.
3. Fragment that has experienced a high temperature TOV event shows less non linearity and

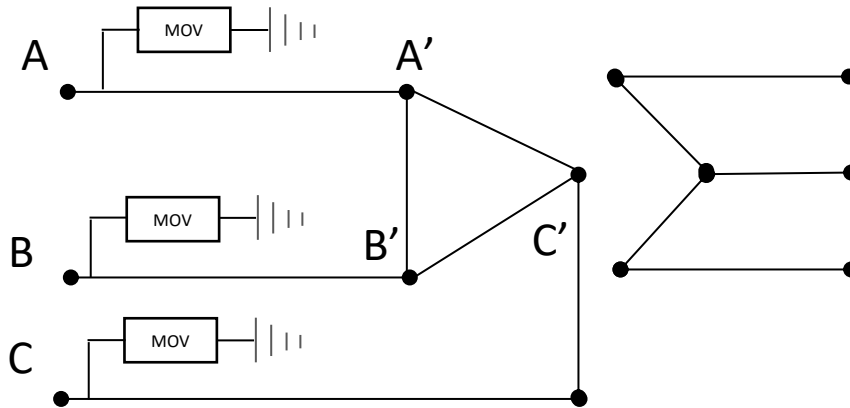
Single Phasing on Wye/Delta circuits

If B and C are energized and A is open, the voltage at A can float as high as Phase to Phase voltage (of 37.3 kV in this case) due to backfeed from the secondary on the transformer. Any voltage above 31.5kV at A' in this case (MCOV of the arresters) will put the A phase arrester in conduction. Because it is a backfeed situation, the available current at that point is very low (few amps or less) and it just raises the temperature on the arrester until it burns up. Sometimes it only burns the fiberglass structure internally, but sometimes can turn the rubber housing into a molten mess too.

The arrester is the right rating for the system if there is a fault on one phase, but it is not sufficient when the circuit experiences single phasing. If all three fuses had operated, this failure would not have happened. For this reason the overcurrent device needs to be a three phase device, not single phase fuses or cutouts.
