Small Power Station Surge Protection Analysis and Plan

Jonathan Woodworth ArresterWorks

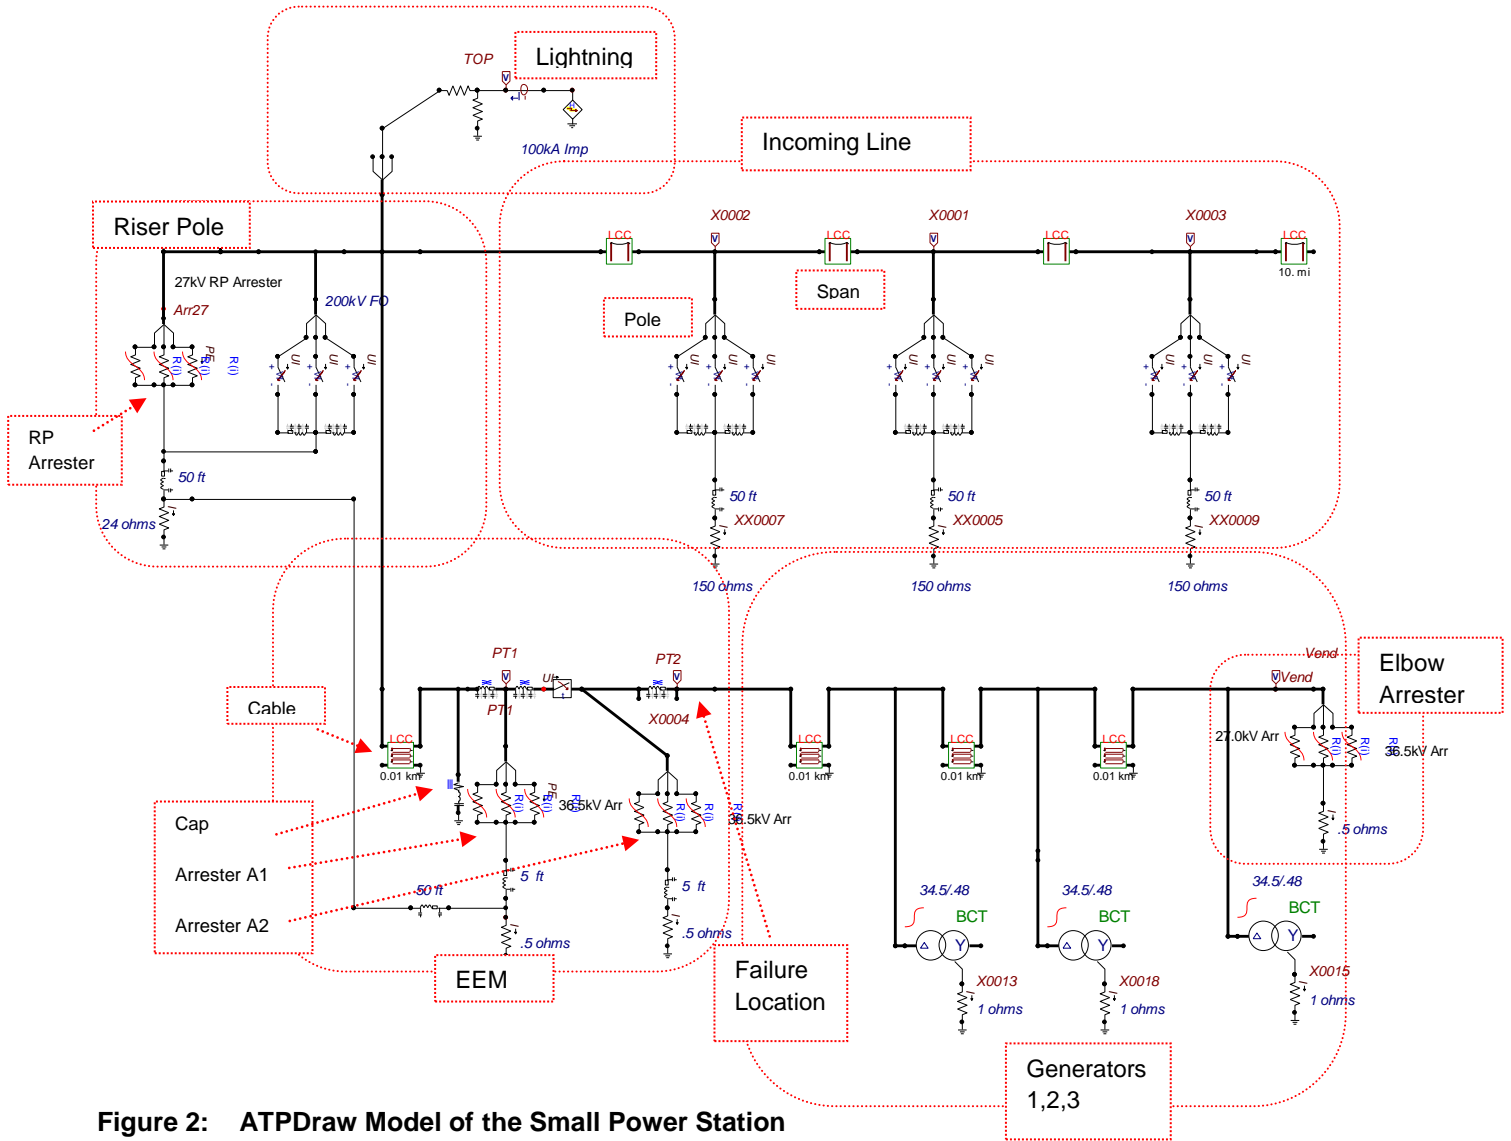
Figure 2: ATPDraw Model of the Small Power Station

The station was modeled for transient analysis using ATP and ATPDraw [1]. The provided one line diagram and physical inspection was used for the model dimensioning and component location.
